# Product Safety Recall

## Metzeler Tourance Next

## Metzeler Tourance Next II

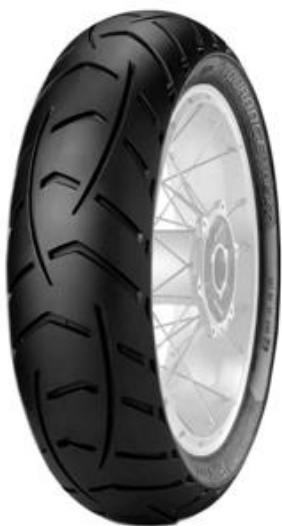
**IDENTIFICATION:** All tyres with Tyre ID and Date Code combination listed below.

Brand	Model Name	Tyre ID on sidewall	Production Date Code on sidewall
Metzeler	Metzeler 150/70R18 M/C TL 70V Tourance Next	(1)EB 0M X033	From 4816 to 2424
Metzeler	Metzeler 150/70R18 M/C TL 70V Tourance Next II	(1)EB 0M 614L	From 3521 to 2624

**Why the product is recalled:** Under certain tyre service conditions (e.g., low inflation pressure, heavy load, road conditions, mileage at almost the half of tyre life, etc.), irregular tyre wear may develop, which, over time, may result in breakage of the zero-degree reinforcement. If this condition is not promptly detected, it may lead to potential detachment of parts of the tread layer and/or sudden air loss.

**Hazard:** Partial detachment of the tread layer and/or a sudden loss of air pressure may cause loss of control, increasing the risk of a crash.

1. Metzeler recommends to stop using the motorbike immediately and have the tyre checked by your Metzeler Dealer.
2. Pirelli will support your dealer in replacing the affected tyres you return.
